KOOTENAI DEVELOPMENT IMPOUNDMENT DAM
JANUARY 2011 ROUTINE OWNERS INSPECTION

Prepared for: The Remedium Group

Prepared by: Kurt Hafferman, P.E.

Inspection Date: February 04th, 2011
Report Date: February 07th, 2011

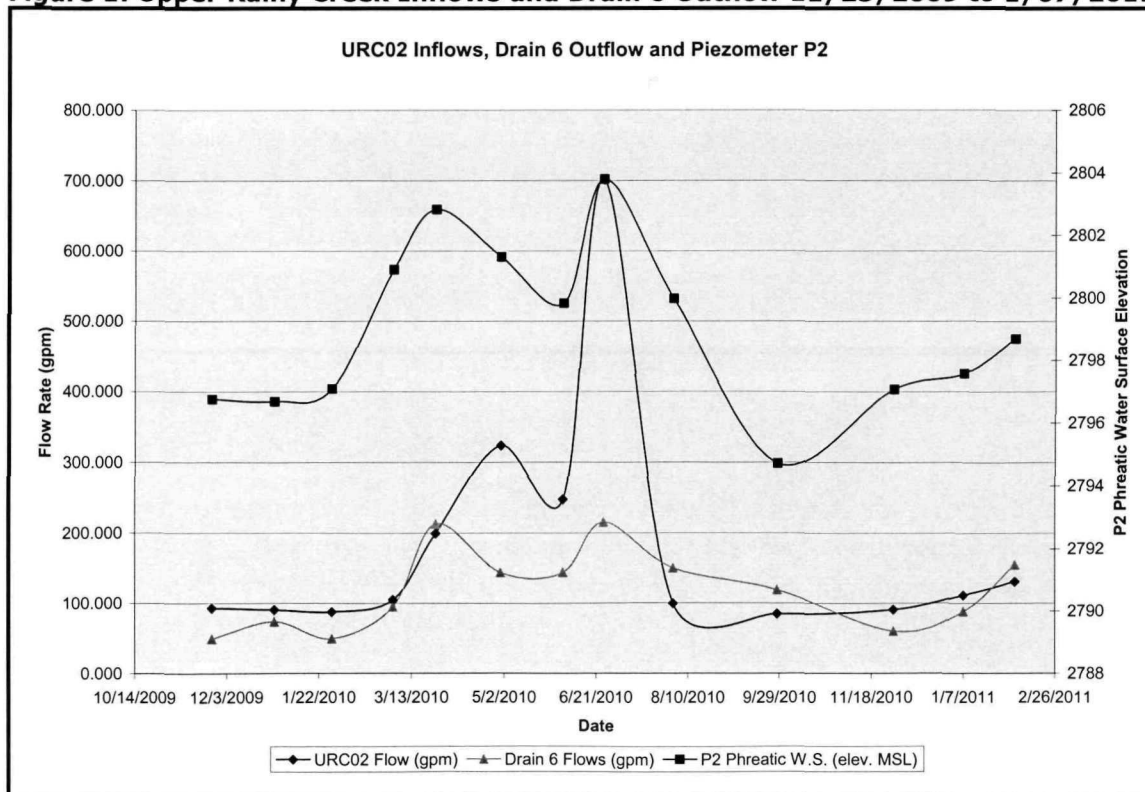
Figure 1: Upper Rainy Creek Inflows and Drain 6 Outflow 11/25/2009 to 1/07/2011

Drain 6, the main drain at the toe, again increased flow. The increase was from 87.9 gpm to 154.64 gpm, an increase of 66.74 gpm, or 43.1% since December measurements. The steady increase in flows follows lower than expected flows during the November 2010 and increased flows in the December 2010 inspection. The drain flows recorded are slightly higher than the same time last year, which correlates with the increase in precipitation so far this year. A graph of the Rainy Creek inflows and drain 6 outflows from November 25th of 2009 to this inspection is shown in Figure 1 below.

Although it is not unusual to have an increase of inflows and a rise in Piezometers, it was still unusual for this time of year. As of this inspection, drain flows have increased and are now greater than recorded inflows.

No maintenance issues at this time. Continue to closely monitor inflow, piezometer readings and drain 6 outflows for fluctuations. Watch for changes in drain 1 and drain 2 flows. Monitor spillway flows and drain 1 and drain 2 flows to see if there is a correlation.

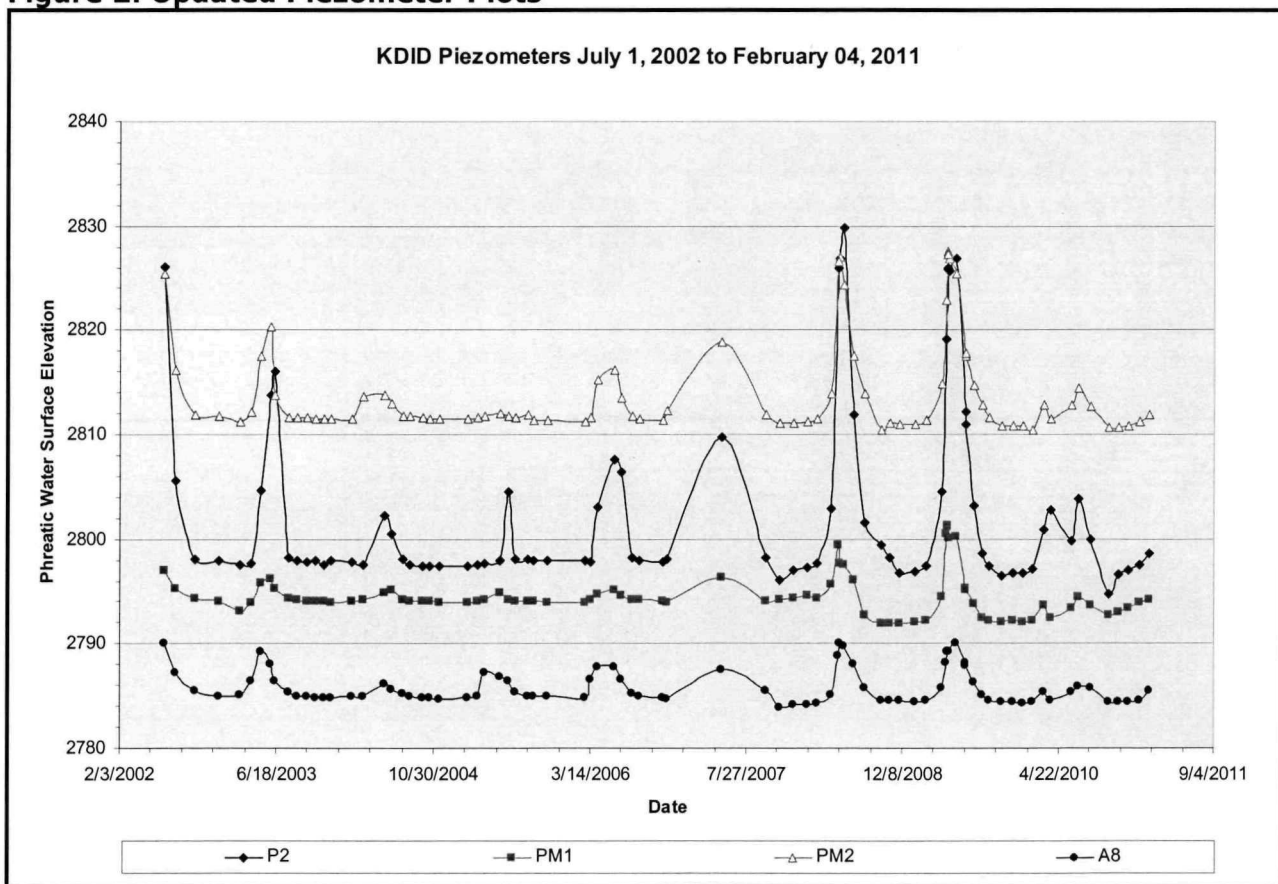
Figure 2: Updated Piezometer Plots

The updated piezometer data is shown in Figure 2 below. It was noted that piezometer readings were lower in the November inspection than in this inspection as can be seen in Figure 2 below. This is unusual as we typically have declining inflows and piezometer readings until late February in most years we have recorded data (since 2007). It is assumed that the warmer temperatures and increased precipitation this year has resulted in at least one major rain on snow event that melted approximately 50% of the snow on the site since the last inspection. It appears that these events have shown up as inflows and have routed through the reservoir and embankment and are now present as higher piezometer readings. As stated above, we have recorded outflows that are now greater than inflows so we anticipate stabilized and falling inflow, piezometer and outflow readings next month as long as temperatures and precipitation return to more normal levels.

These graphs show that the phreatic water surface has risen in the piezometers to similar to 2006. As BHI did not begin inspections until 2007, we have never seen these levels onsite at this time of year.

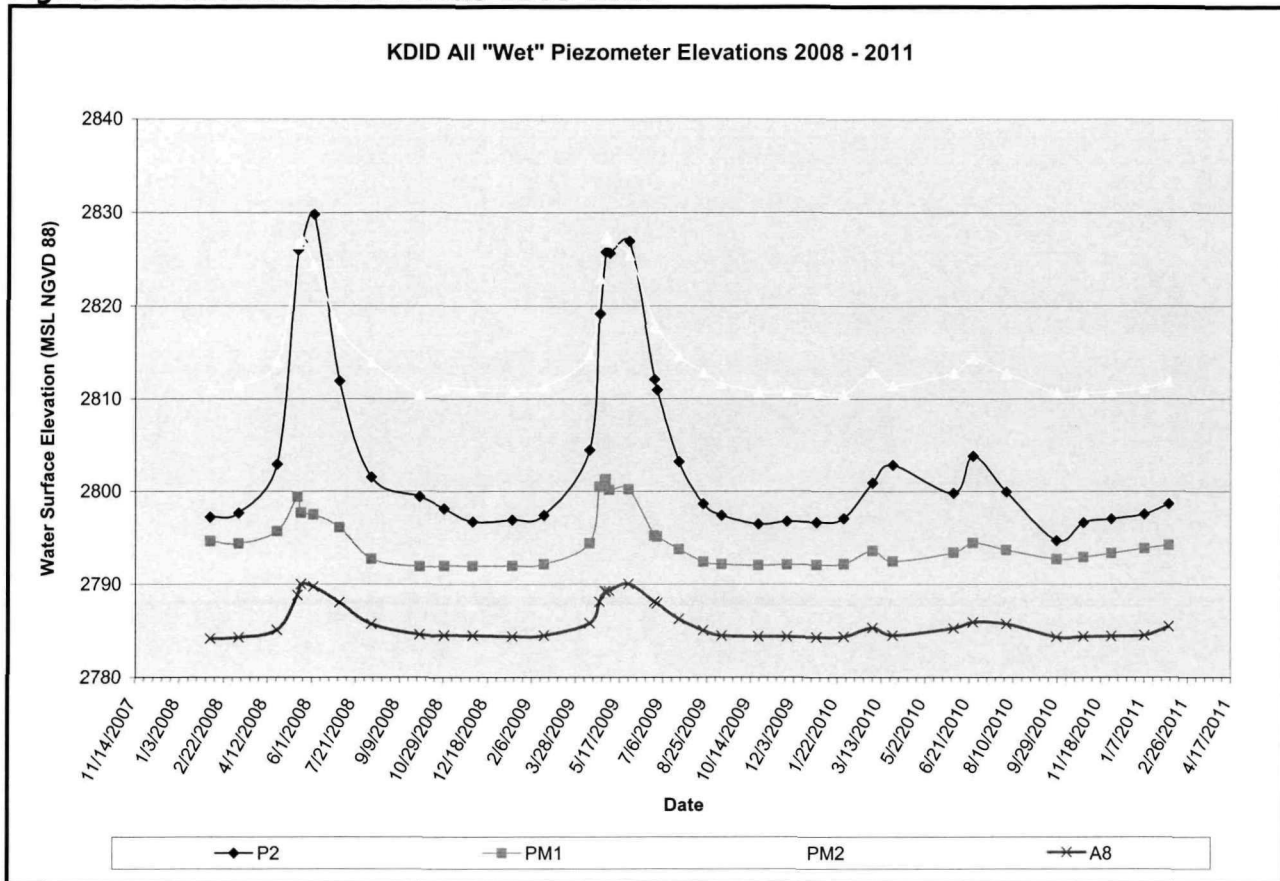
Figure 3: Piezometer Elevations 2008-2011

The graph above again shows a continued rise in piezometers P2, PM1 and PM2 as discussed above which also does not show up as more pronounced in other years. The only anomaly is that we typically see a steady decline from late October through late February. This is, again, likely contributed to higher snowpack levels than we have seen since BHI began inspections.

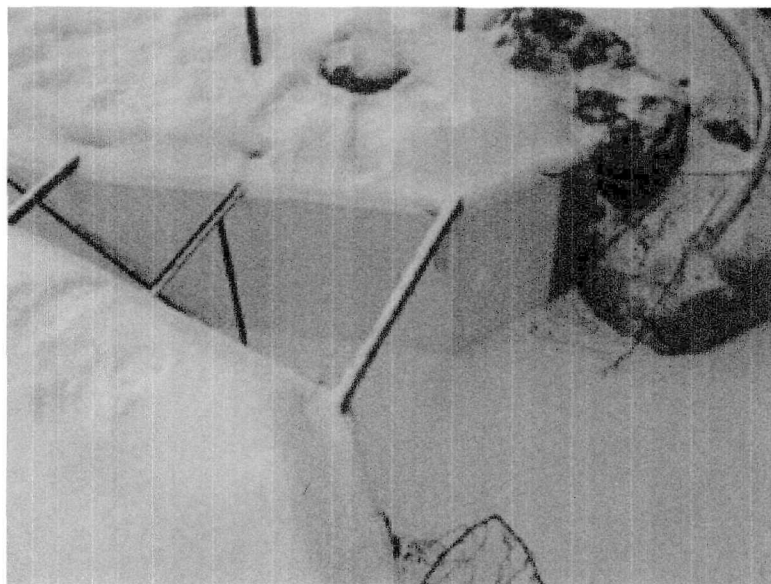
LRC-06 Inlet - Frozen

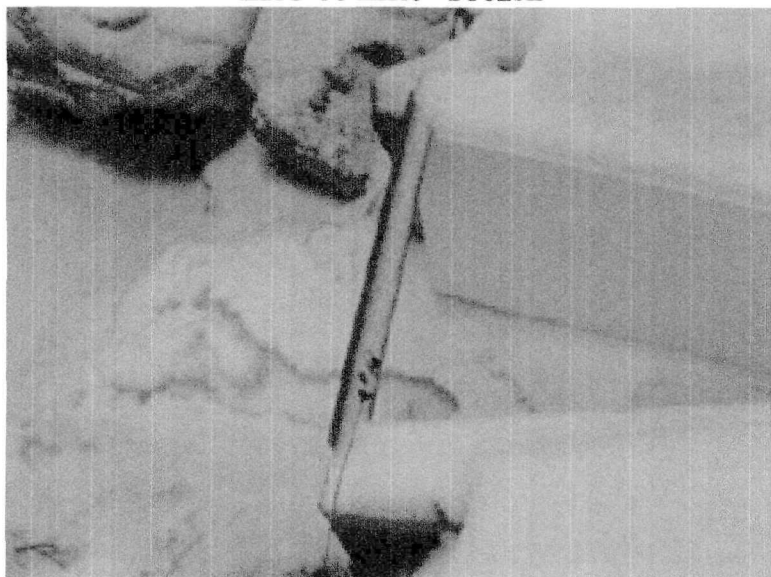
F-Seep – Leak all flows beneath flume

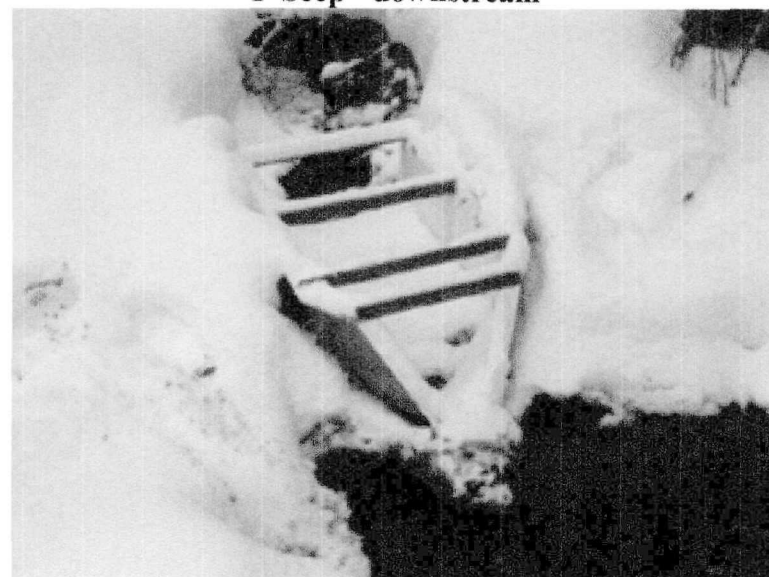
F-Seep – Leak at flume inlet

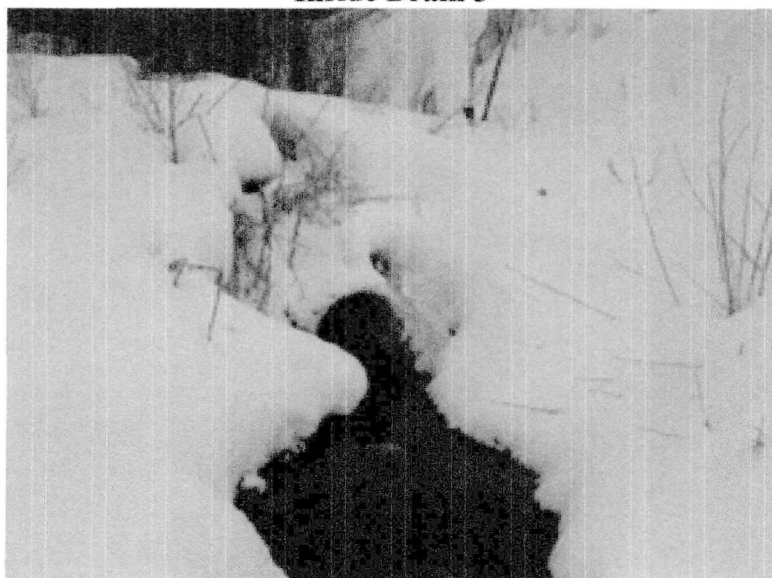
An important note to this discussion is the flow seen from Drain 2 during this inspection. BHI has never seen water in Drain 2 during a winter inspection. Until further analysis can prove otherwise, we attribute this flow to the construction repairs made to the drain last year. The old drain had a large hole in the pipe and a portion of the pipe has now been replaced. We assume that low flow water would flow into the hole and into the base gravel and was never seen in the outflow until it increased above seepage rates. It was odd that we did not see flows after construction activities but given the higher precipitation levels so far this year and the mid season rain on snow, we do not see this as an anomaly.

Drain 2

Item 47 - Flow observed in drain 2 for first time. Likely due to increasing flows and construction activities last year to fix the drain. BHI will closely monitor any changes in the future. No other anomalies noted.

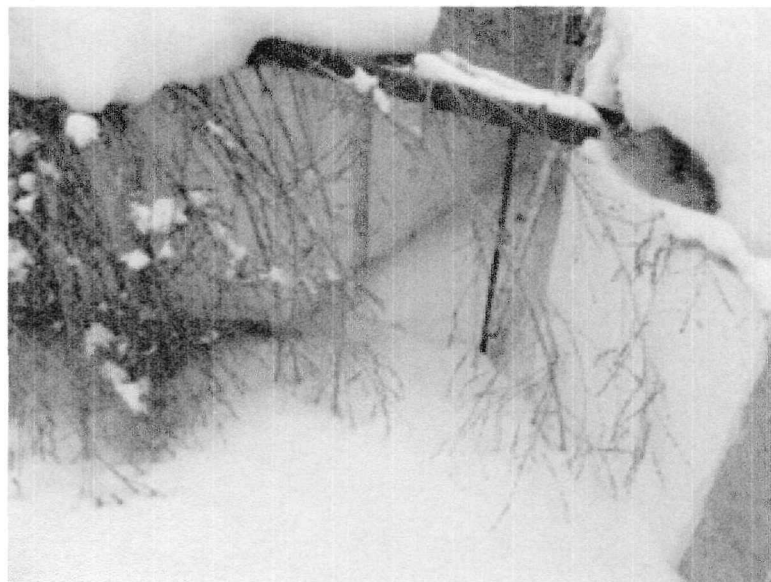
CC-02 Flume - Frozen
